Compound challenges in a water injector

AkerBP

Well description

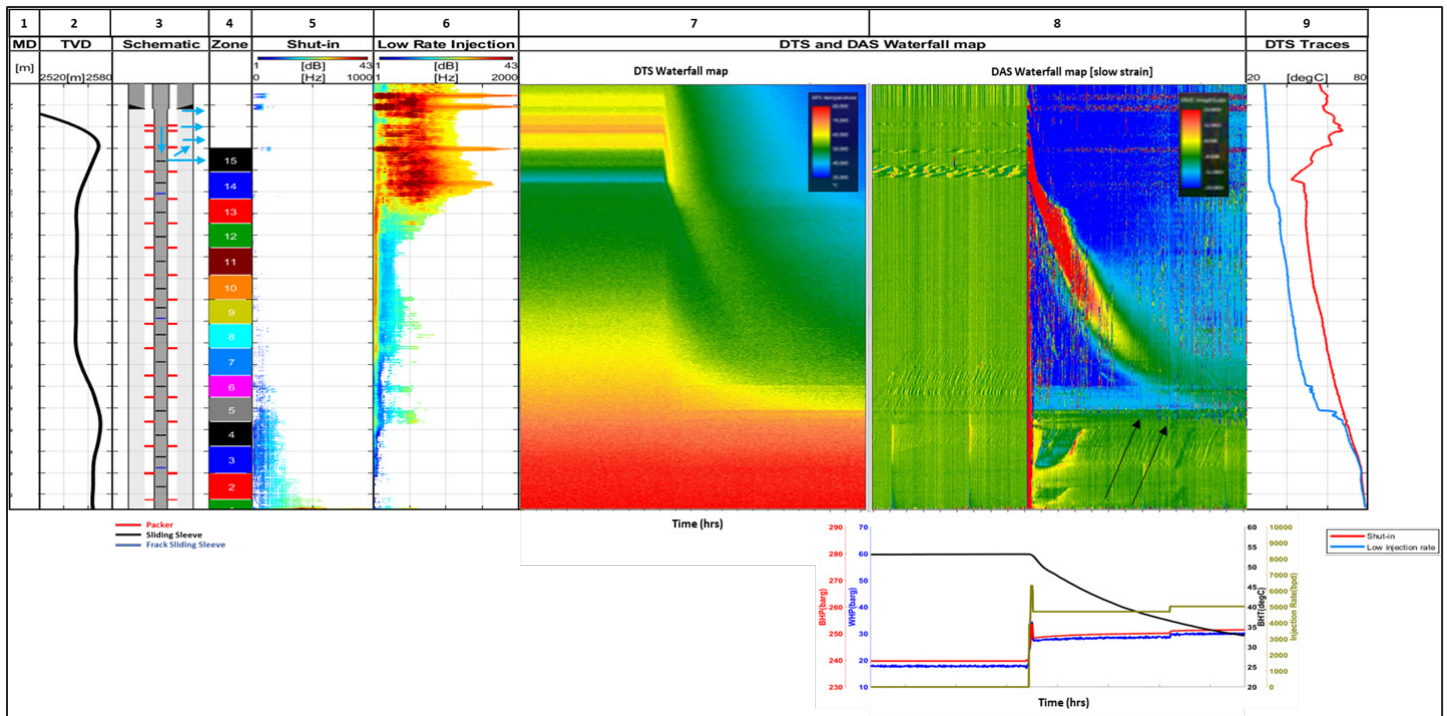
Figure 2 - Composite plot from report

- » Residual acoustics detected adjacent to heel-ward zones during the shut-in period indicative of cross flow in this well. This is visible on the frequency distance plot obtained during the shut-in period (Track 5).

- » At the start of injection, warmed-up fluid in the vertical casing is pushed into the reservoir. The thermal and strain effects of this are seen on the DTS and DAS Slow Strain waterfall maps (Track 7 & 8).

- » As injection progresses at this rate, upward diagonal patterns originating from depths below zone 1 were also observed. These are annotated by black lines on the slow strain DAS map in Track 8. The Speed of sound analysis, shown in Figure 4 below, identified the cross-slow to be related to inconspicuous oil production from higher pressure zones in the toe section of the well.

- » Dominant fluid intake was detected across zones 14-15 with expected water intake in other zones. This conclusion was reached owing to the convergence of both DAS & DTS datasets as low acoustic signals and insignificant thermal variations were observed & the operating injection pressure.

- » First indications of Out-of-Zone Injection were detected at this time with consistent acoustic signals and temperature changes observed between zone 15 and the non-perforated section above as seen in Tracks 5,6 and 7. These were further validated by data at later times.

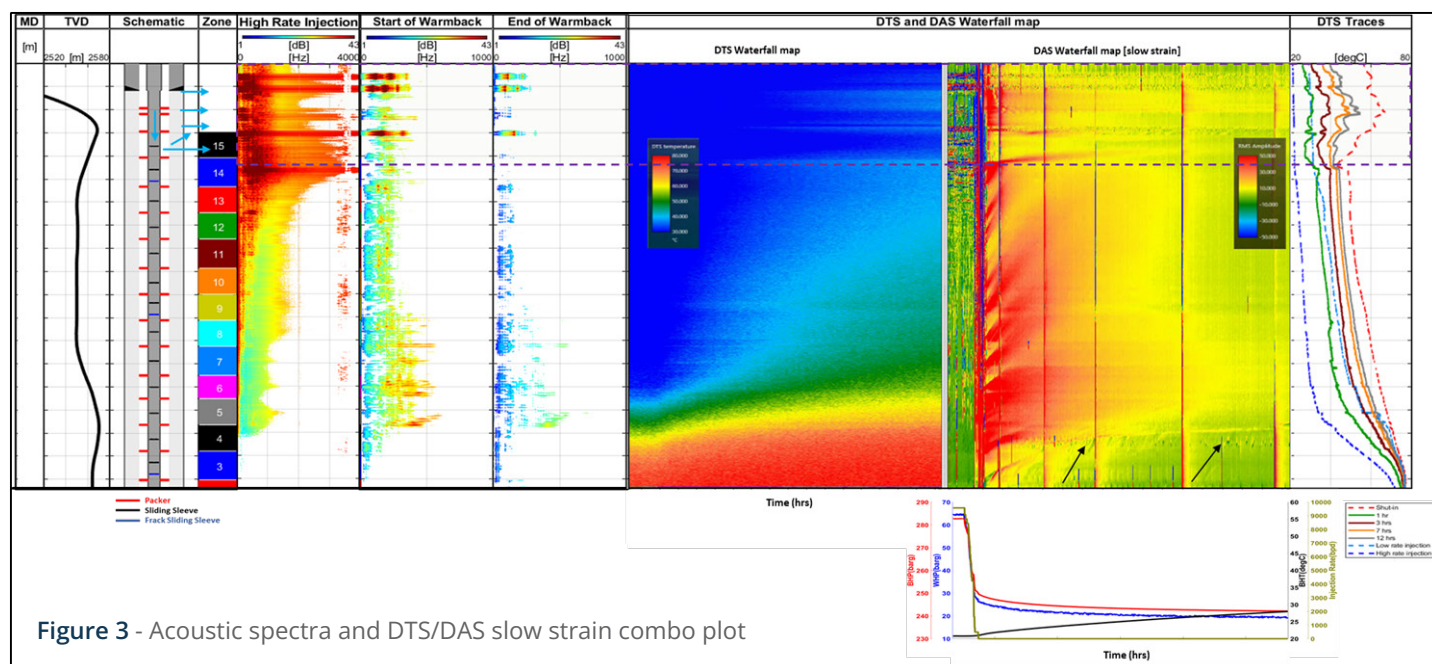
Figure 3 - Acoustic spectra and DTS/DAS slow strain combo plot

- » Higher noise activity as the injection rate is increased. But acoustic signals indicative of water intake across heel-ward stages remain unchanged.
- » On the contrary, these less-active zones appear active during the warm-back as seen on the spectral plots, and as informed by diagonal patterns detected on the slow strain map.

- » These further confirmed active communication between this well and the zone described in point (3) above.
- » The warm back effect is not only observed across the injection interval but above zone 15. These thermal effects and residual acoustic signals confirmed active Out-of-Zone injection in this well.

At the end of this assessment, it was established that the sliding sleeve door linked to zone 14 was compromised and remediation was to be planned for.

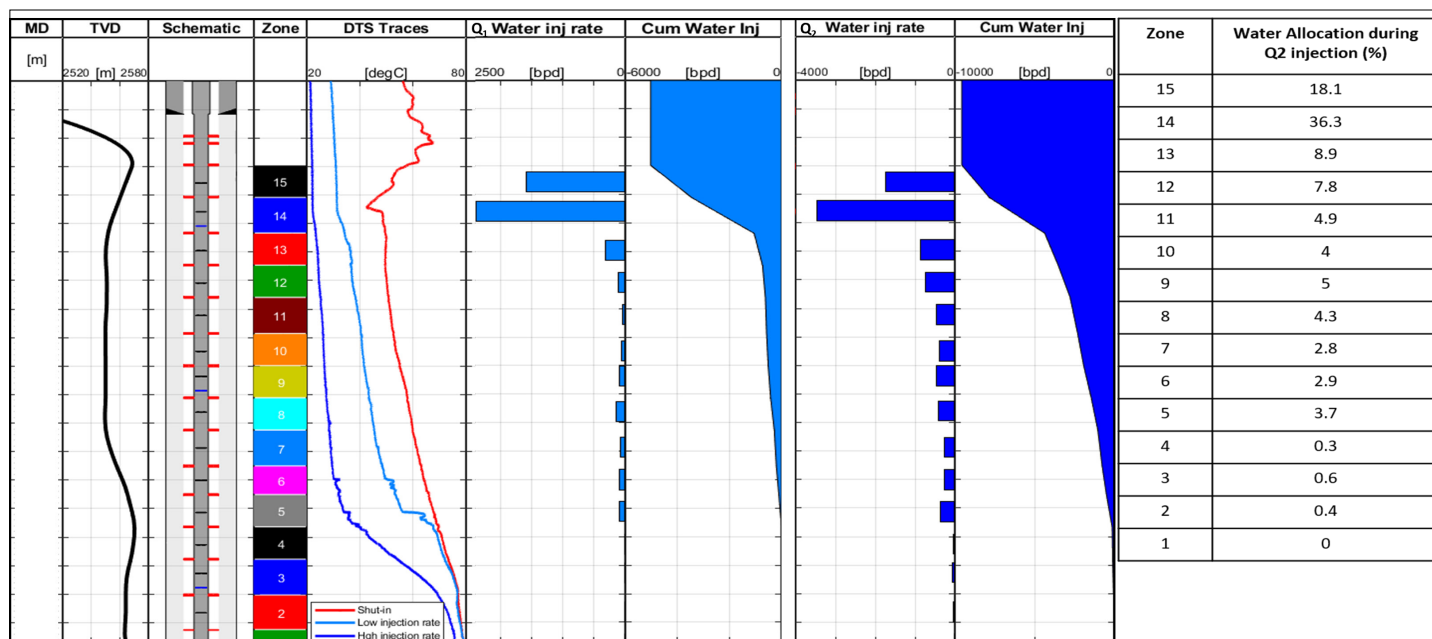
Figure 4 - Inflow allocation

Figure 4 shows the estimated inflow allocation profiles using Silixa's unique DAS & DTS injection Profiling Solution

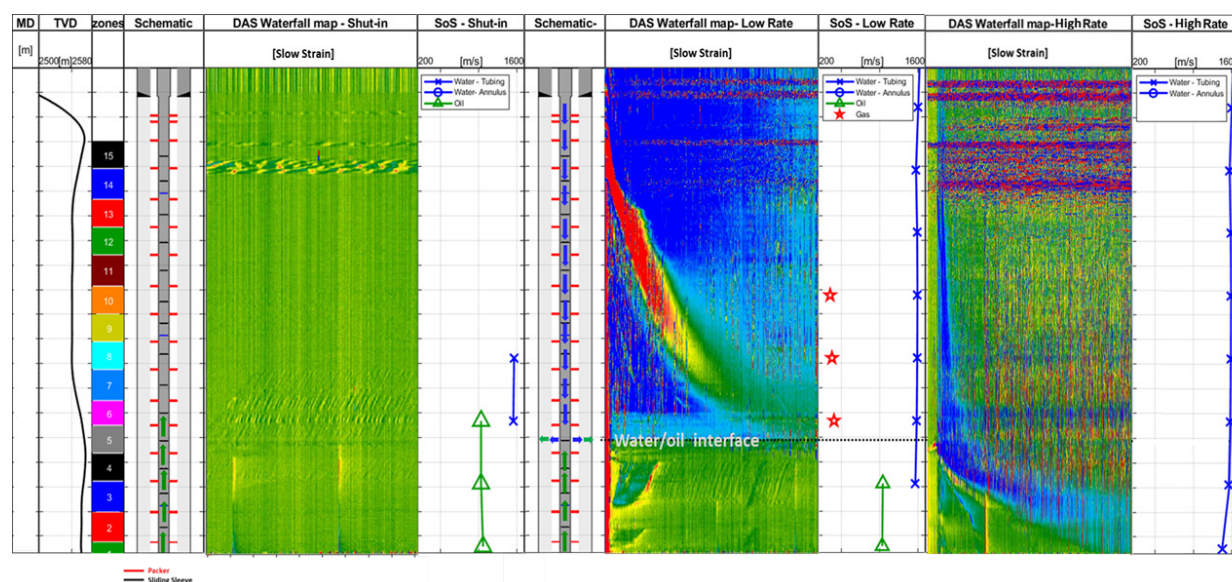
Figure 5
Speed of sound and DAS waterfall combo plots

An in-depth cross-flow analysis was performed by computing the speed of sound (SOS) profile, indicative of the fluid composition, over the different well operating conditions, and displaying it alongside the Slow strain DAS thermals plumes, as shown in **Figure 5**.

During the initial shut-in, the speed of sound profile identifies oil produced from the lower toe zones moving up the well, as also displayed by the DAS slow strain waterfall map.

During the low injection rate, the water/oil interface is displaced towards the lower toe zones, however the oil production is still present, as shown by both the SOS and the Slow strain features. Only once water injection at high rate is reached, the pressure is significant enough to push the oil back into the reservoir, and effective water injection occurs.

The last SOS track in **Figure 4** shows no oil detection and the slow strain DAS shows the thermal plume reach the bottom last stage of the horizontal.
