Compound challenges in a water injector

AkerBP

Well description

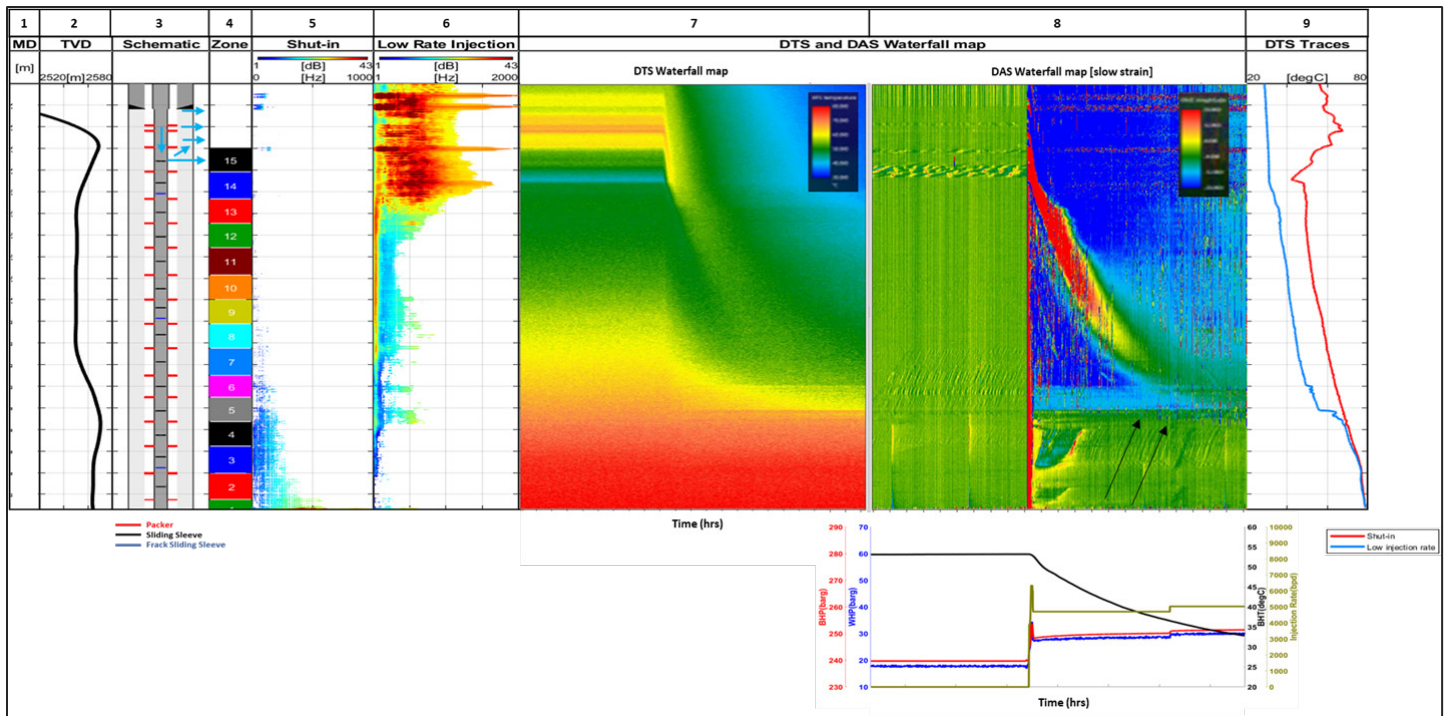
Figure 2 - Composite plot from report

- » Residual acoustics detected adjacent to heel-ward zones during the shut-in period indicative of cross flow in this well. This is visible on the frequency distance plot obtained during the shut-in period (Track 5).

- » At the start of injection, warmed-up fluid in the vertical casing is pushed into the reservoir. The thermal and strain effects of this are seen on the DTS and DAS Slow Strain waterfall maps (Track 7 & 8).

- » As injection progresses at this rate, upward diagonal patterns originating from depths below zone 1 were also observed. These are annotated by black lines on the slow strain DAS map in Track 8. The Speed of sound analysis, shown in Figure 4 below, identified the cross-slow to be related to inconspicuous oil production from higher pressure zones in the toe section of the well.

- » Dominant fluid intake was detected across zones 14-15 with expected water intake in other zones. This conclusion was reached owing to the convergence of both DAS & DTS datasets as low acoustic signals and insignificant thermal variations were observed & the operating injection pressure.

- » First indications of Out-of-Zone Injection were detected at this time with consistent acoustic signals and temperature changes observed between zone 15 and the non-perforated section above as seen in Tracks 5,6 and 7. These were further validated by data at later times.

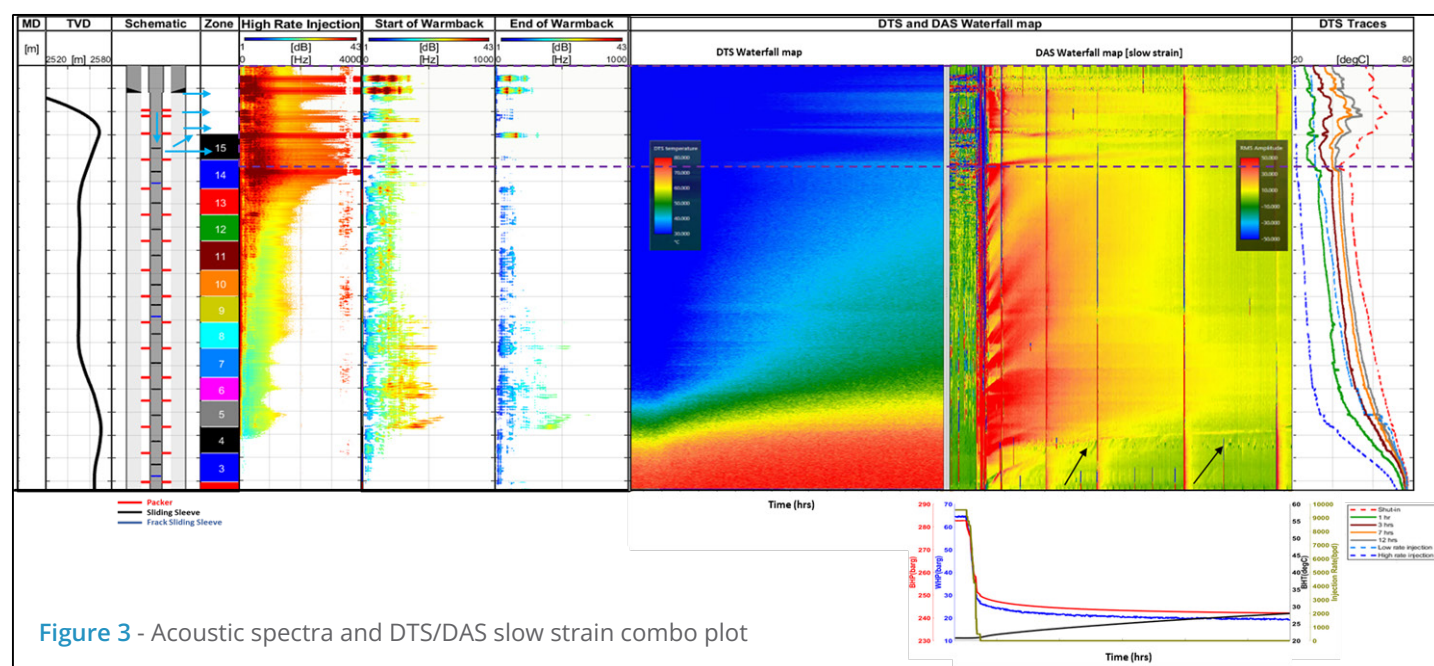
Figure 3 compares frequency spectra from later times with key findings discussed below:

- » Higher noise activity as the injection rate is increased. But acoustic signals indicative of water intake across heel-ward stages remain unchanged.
- » On the contrary, these less-active zones appear active during the warm-back as seen on the spectral plots, and as informed by diagonal patterns detected on the slow strain map.

- » These further confirmed active communication between this well and the zone described in point (3) above.
- » The warm back effect is not only observed across the injection interval but above zone 15. These thermal effects and residual acoustic signals confirmed active Out-of-Zone injection in this well.

At the end of this assessment, it was established that the sliding sleeve door linked to zone 14 was compromised and remediation was to be planned for.

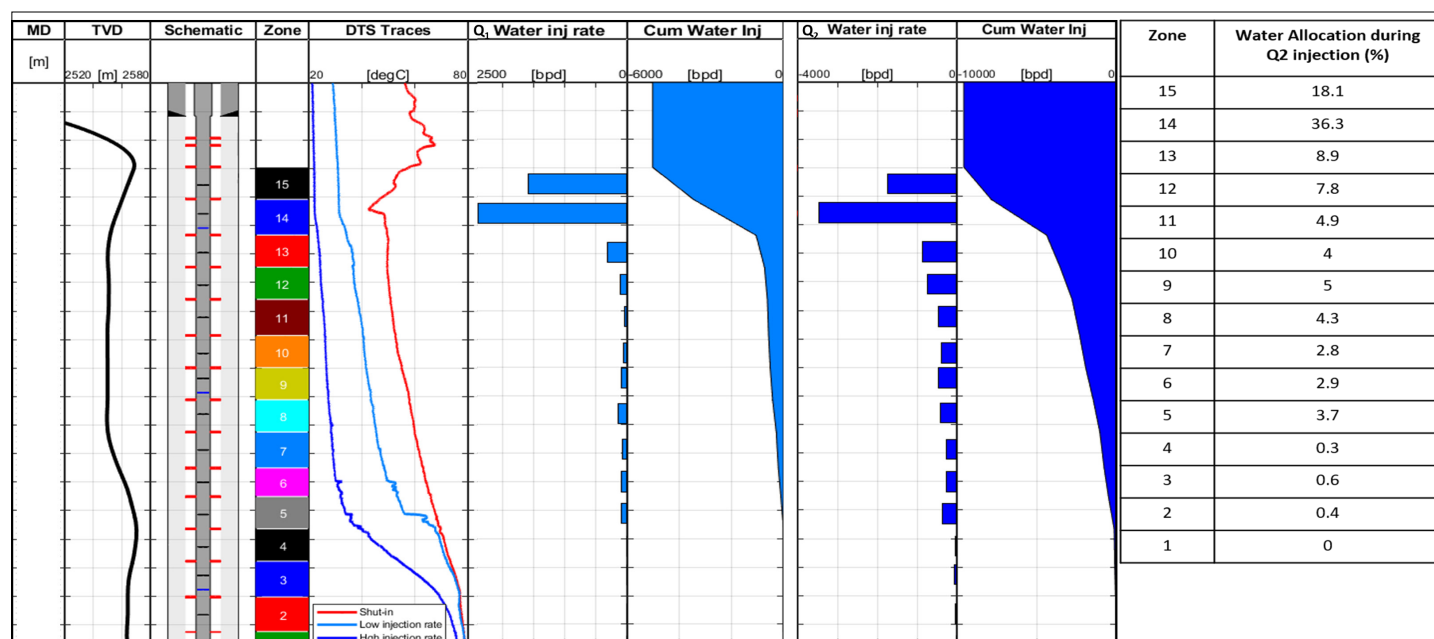
Figure 4 - Inflow allocation

Figure 4 shows the estimated inflow allocation profiles using Silixa's unique DAS & DTS injection Profiling Solution

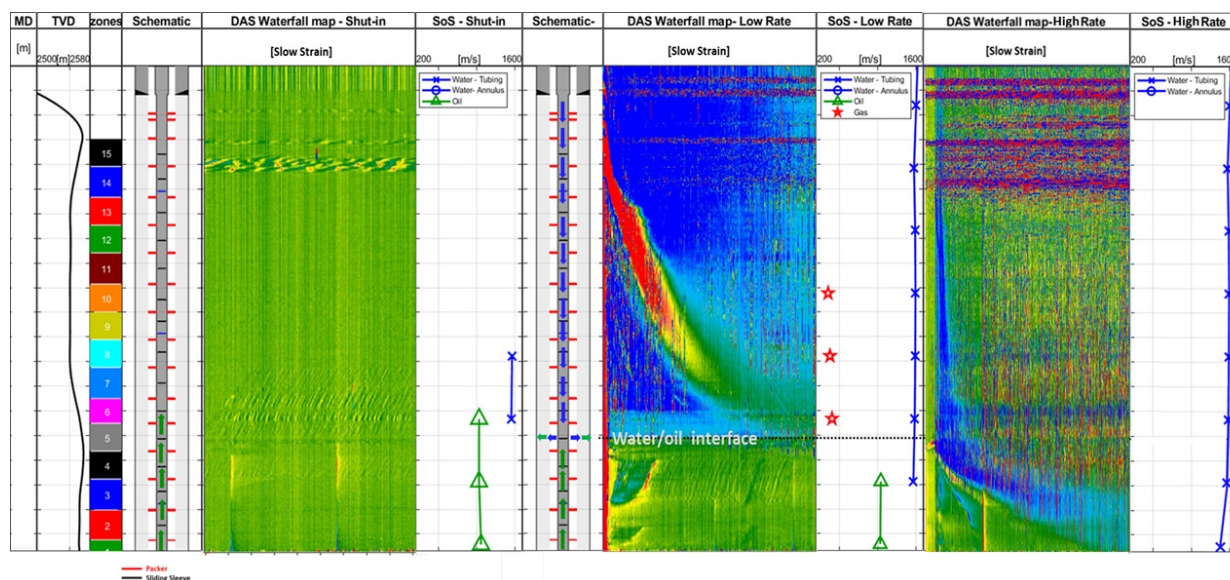
Figure 5
Speed of sound and DAS waterfall combo plots

An in-depth cross-flow analysis was performed by computing the speed of sound (SOS) profile, indicative of the fluid composition, over the different well operating conditions, and displaying it alongside the Slow strain DAS thermals plumes, as shown in **Figure 5**.

During the initial shut-in, the speed of sound profile identifies oil produced from the lower toe zones moving up the well, as also displayed by the DAS slow strain waterfall map.

During the low injection rate, the water/oil interface is displaced towards the lower toe zones, however the oil production is still present, as shown by both the SOS and the Slow strain features. Only once water injection at high rate is reached, the pressure is significant enough to push the oil back into the reservoir, and effective water injection occurs.

The last SOS track in **Figure 4** shows no oil detection and the slow strain DAS shows the thermal plume reach the bottom last stage of the horizontal.
